Implementations of Autonomous Maintenance to Relieve Stoppages on PT NIKF – Sachet Packaging Chain

Abstract—Autonomous maintenance taught operator to keep devices, create cooperation each employer and did problem solving that occurring in machine. This research described assembling of autonomous maintenance on PT NIKF – minor stoppages trouble in sachet production line. Our team used the OEE method to know the latest line condition and variety losses that causing the performance were not optimal. After that, the next steps were using visual losses map and diagram Pareto to get the detail (component with many losses). By Go See Think Do, the researcher could find much maintenance that must be done in SIC line 1. Through the application, this effort could reduce the losses of minor stoppages - 79,52%.

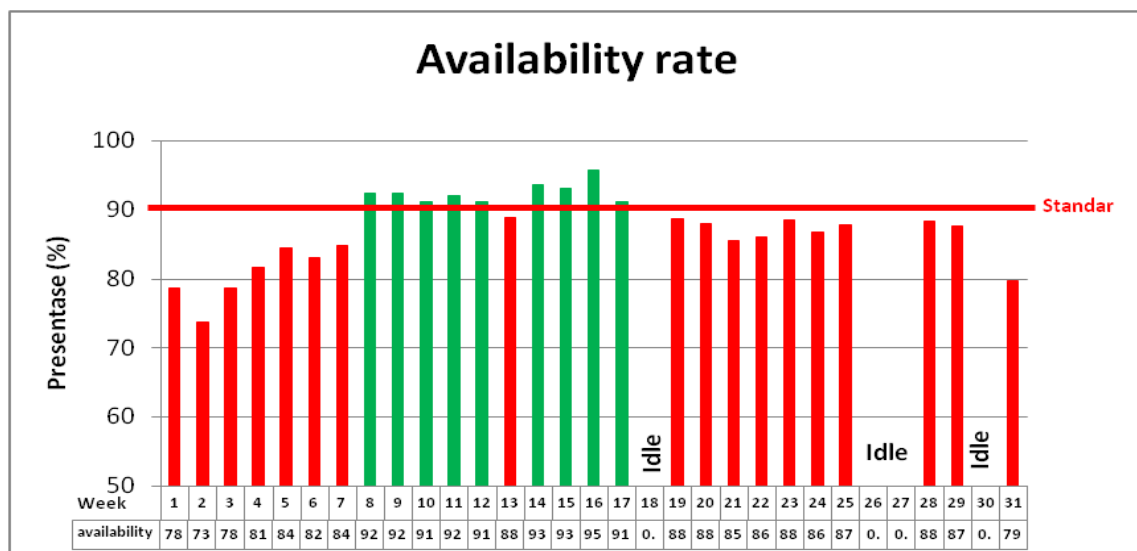
Figure 3. Trend of availability ratio point

Achievement of OEE in SIC line 1 still often did not reach the standard score. The world class manufacturing

OEE was 85% [4]. By the estimation, low of availability point was failure – 78,70%. It should be 90%. Highly unplanned stoppages were 21.9333,93 minutes for 31st and 1.668 minutes in last week. The both of reasons also supported the existing trouble. So, the researchers would fix the effectiveness of machine by reducing amount of unplanned stoppages. Another researcher gave a statement that the OEE tool could help to optimize the performance of existing capacity [5]. OEE score 63-79% indicated that experiment had improvement in productivity and quality of product [3].

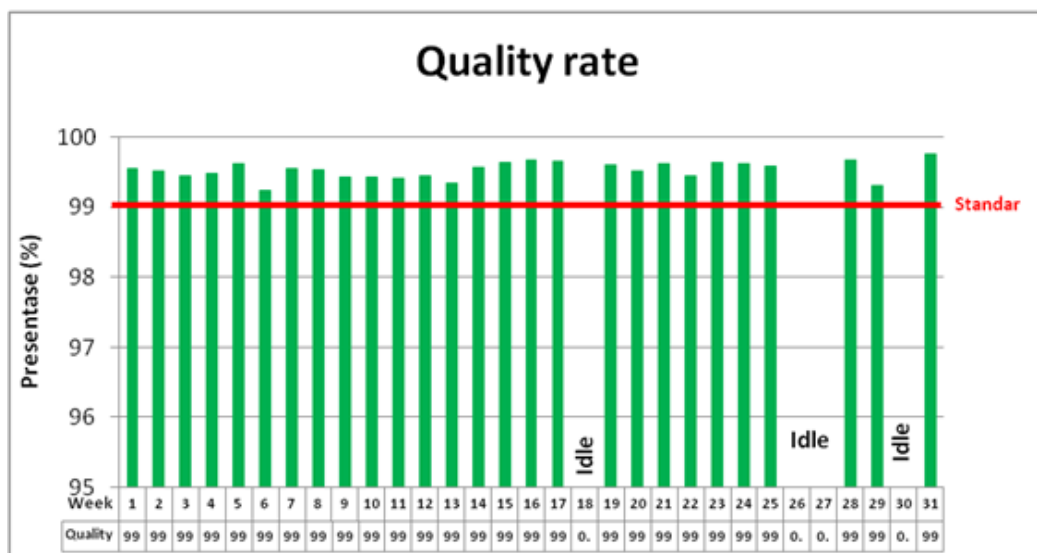
Figure 5. Inclination of quality ratio.
